Assessment of Failure Mechanisms in an Industrial Firewater Pipeline: A Case Study

³ Bandar Imam Petrochemical Complex (BIPC) Research Center, Mahshahr, Iran

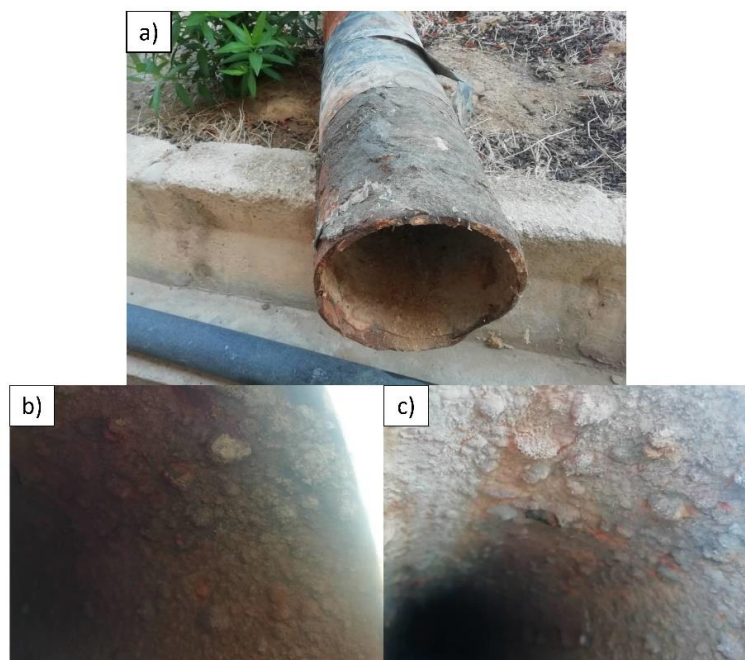
As illustrated in Figure 1a, the destruction of pipe wrapping coated on the outer surface and also formation of huge amount of precipitation and tubercles (Figure 1b and c) are clearly observed in the inner surface of the pipelines. Tubercles can be explained as complex deposits colonies, including: metal oxides, remaining of living microorganisms, and corrosion products [47].

Figure 1. The field illustrates the destruction of external coating (Wrapping) and the formation of vast amounts of deposits and tubercles

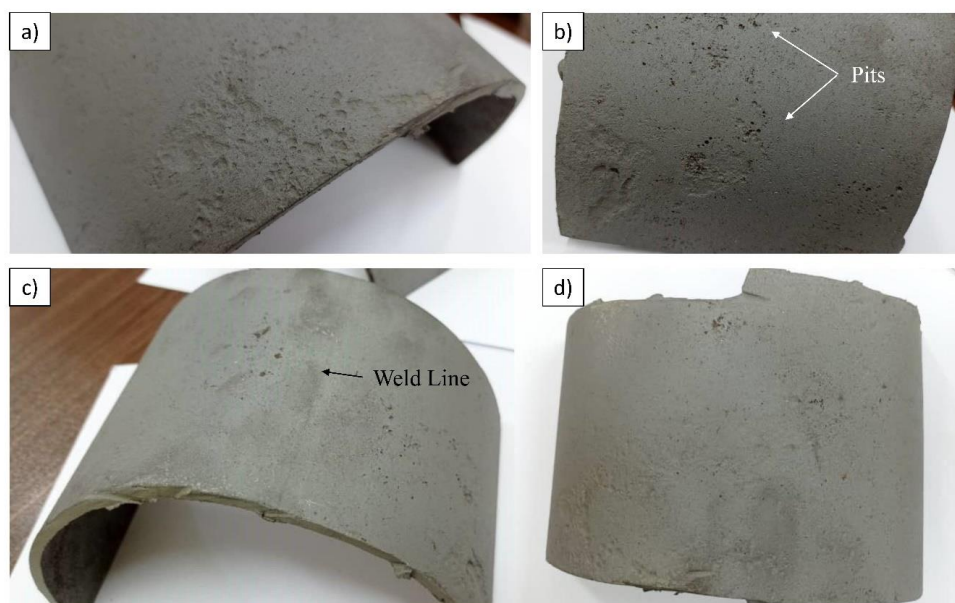
Figure 2. The external surface of the firewater pipeline after removing the deposits

As demonstrated in Figures 2 and 3, the occurrence of corrosion, appearance of pits, and reduction in thickness in some regions of the pipe's external surface is vividly observed. The

leading cause of corrosion on the external surface could be the destruction of wrapping coating employed under cathodic protection system.

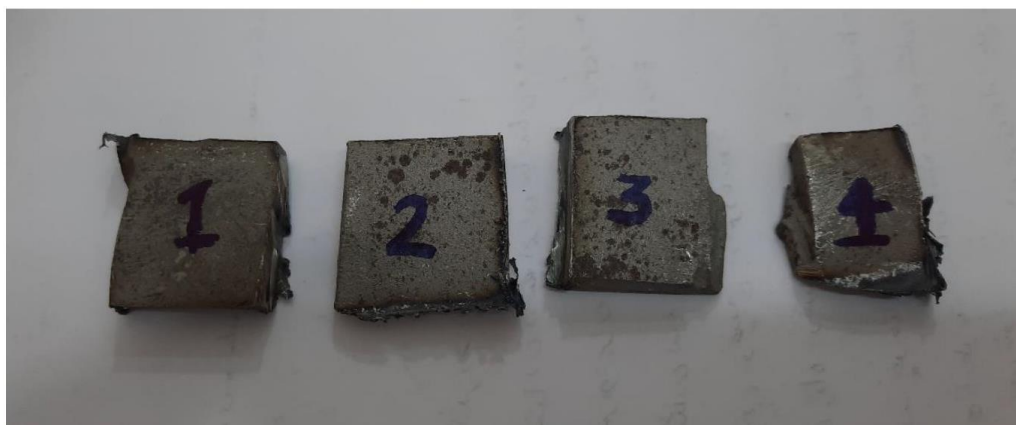
Figure 3. The firewater pipeline's external (Bottom and Top) surfaces after removing the deposits

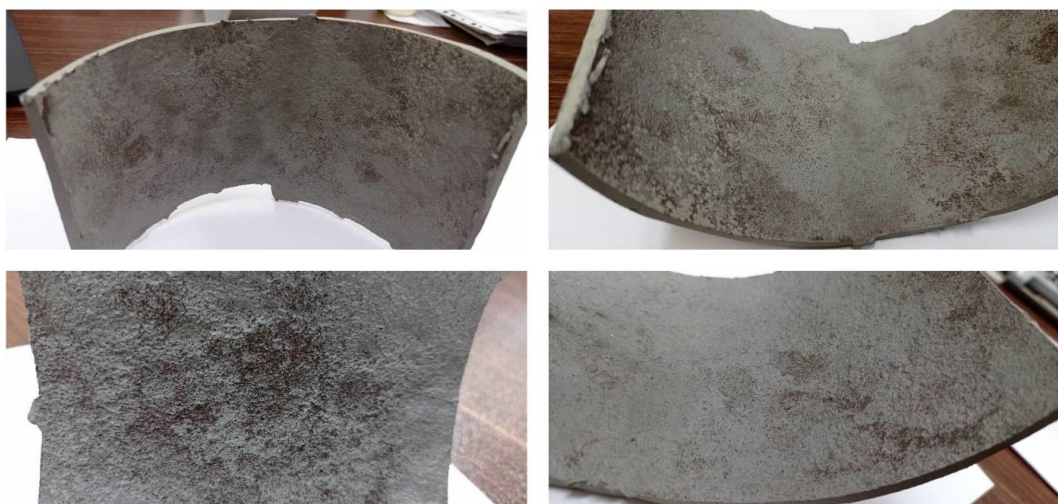
Figure 4. The internal surfaces of the firewater pipeline after removing the deposits

As seen in Figure 4, it is observed that the combined forms of general and localized corrosion have been occurred on the inner surface, indicating the severity of corrosion progress under the formed deposits and corrosion products. According to visual inspection and literature findings, there are three significant features of corrosion observed on the internal surface of the firewater pipeline sample: general corrosion, under-deposit corrosion, and

tuberculation. Tuberculation is originated from forming tubercles which are created due to oxygen concentration cells as the oxygen-deficient sites beneath the tubercles that may play a role as anodic regions and surrounding areas act as cathodic regions and finally result in acute localized corrosion. Tubercles can also reduce the flow and enhance the pumping costs, consequently turning into remarkable efficiency reduction of the firewater pipelines [27, 31].

Deposits formed in the piping system can originate and accelerate corrosion by forming an oxygen-depleted area under deposit, which may play as anodic region compared to the surrounding area, leading to more aggressive corrosive attack under the deposit and occurrence of pitting.

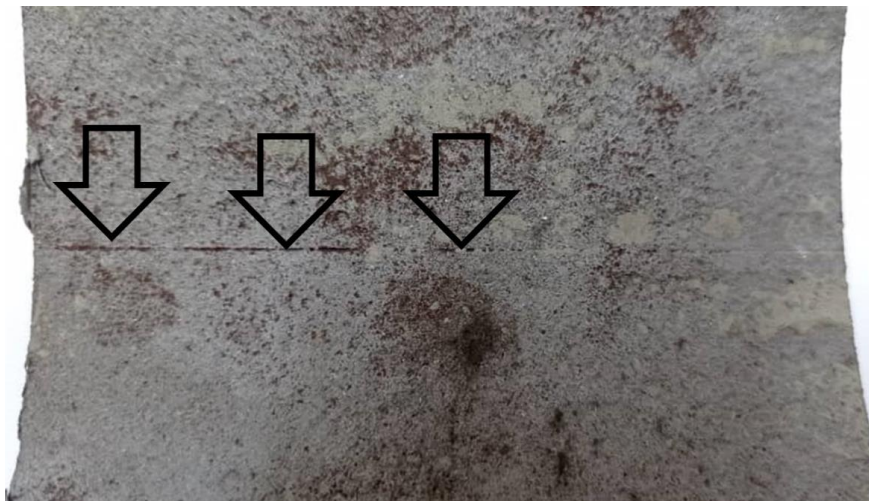
Figure 5 depicts the corroded area of the weld line exhibiting the higher susceptibility of corrosion of weld line due to higher energy of this sensitized zone prone to intergranular corrosion.

Figure 5. The corroded region around the weld line of the firewater pipeline

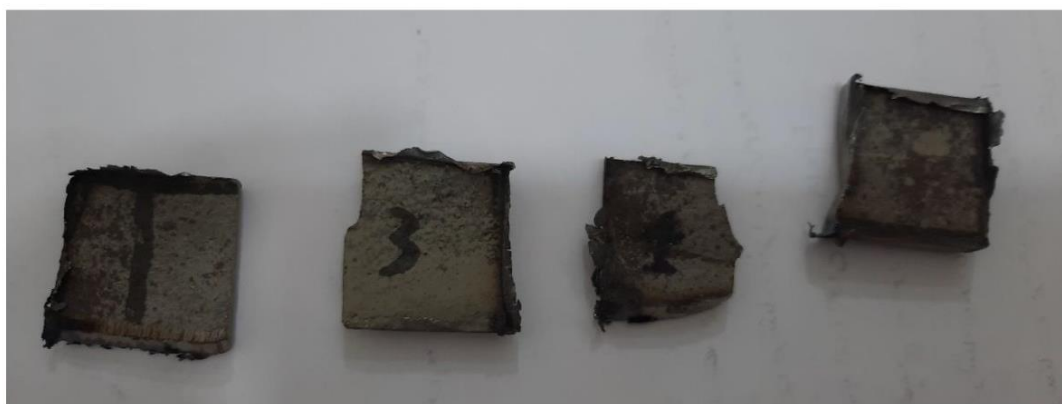
Figure 6. The internal (Bottom and Top) surfaces of firewater pipeline after removing the sediments

The internal (Bottom and Top) surfaces of the firewater pipeline after removing the precipitates in Figure 6, depict the occurrence of corrosion on the internal surface of the pipelines under the precipitates formed during the service.

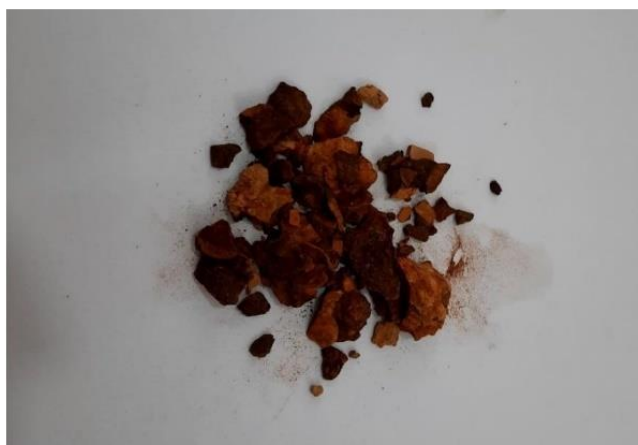
Figure 7 shows the sample prepared from the precipitates (sediments) formed on the internal surface of the FW pipeline to characterize the elements and compounds that sediments are

made of. The visual inspection of these deposits exhibits a brownish and white/yellowish color which may be a sign of forming iron oxide (Fe_2O_3 or Fe_3O_4) and CaCO_3 (Calcium Carbonate), respectively. For further examinations, these deposits were analyzed by EDS, XRD, and XRF analyses, and the corresponding results are discussed in the following.

Figure 7. The sample of deposits formed on the internal surface of the firewater pipeline

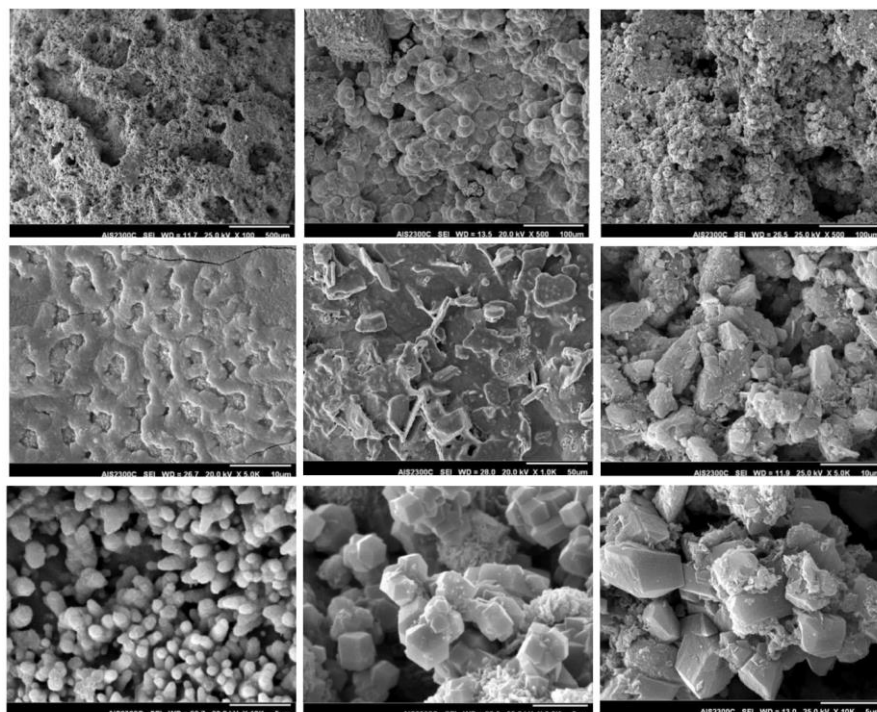
As in Figure 8, the surface morphology of deposits in different areas is reproducible. A wide range of various morphologies such as filaments and spherical particles at four different resolutions is observed. The surface morphology in some areas is compact compared to other regions in which a porous structure and

separated deposits are observed. The formation of precipitates could mitigate the corrosion process. However, the existence of porosities in precipitates results in the creation of dead zones, concentration polarization, and oxygen concentration cells; for instance, due to the formation of tubercles which leads to under-deposit corrosion.

Figure 8. SEM images of precipitates deposited on the internal surface of the FW pipeline at various magnifications

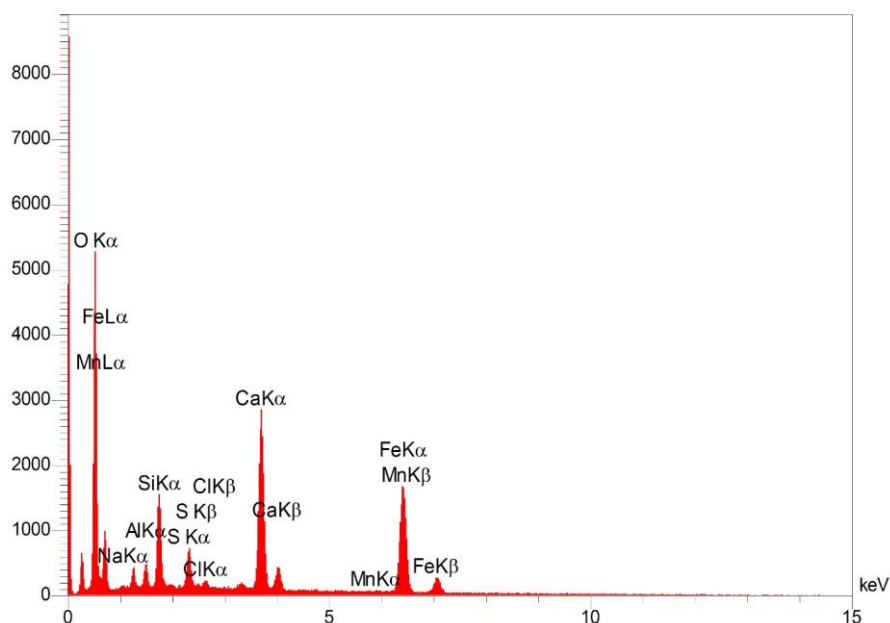
According to Figure 9 and Table 1, the primary peak intensities indicate the presence of major

elements: Fe, O, Ca, Si, Mn, and minor elements: S, Cl, Al, and Na.

Figure 9. The EDS graph of precipitates deposited on the internal surface of the FW pipeline.

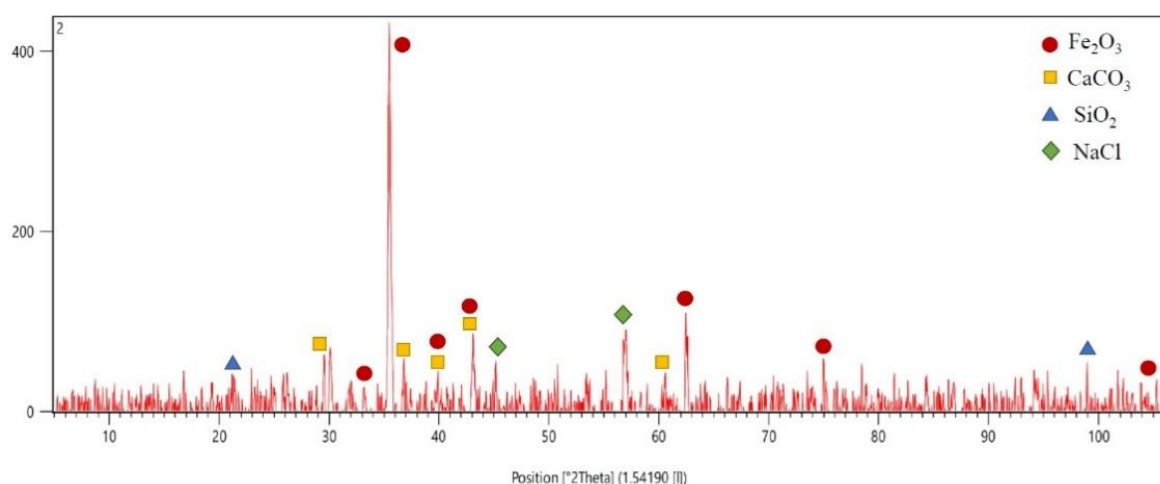
As it is evident from the XRD graph in Figure 10, the significant phases detected in the precipitate sample formed on the internal surface of the pipe are Fe_2O_3 , CaCO_3 , SiO_2 , and NaCl , indicating the presence of iron oxide (Fe_2O_3), silica (SiO_2) calcite (CaCO_3) as corrosion products and NaCl as

Figure 10. XRD pattern of precipitates formed on the inner surface of FW pipeline

Owing to the porous nature of corrosion products and tubercles such as Fe_2O_3 in particular, electrolyte and aggressive anions can readily attack the surface under them and cause the severe form of corrosion. Furthermore, aggressive anions enhance the electrical conductivity of water, leading to a remarkable increase in corrosion rate.
