# Advanced Journal of Chemistry, Section A

**Review Article**

# **Investigating the Fracture Properties of 316 Stainless Steel**

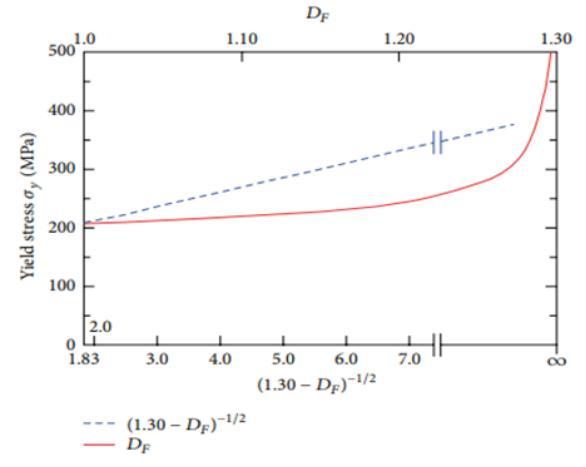
**Figure 1.** Hall-Petch correlations for AISI 316L austenitic stainless steel between yield stress and fracture surface dimensions [4].

The research demonstrates the application of the Hall-Petch equation in establishing a connection between the dimensions of the fractured surface and the grain size concerning the strength of 316L austenitic stainless steel. The findings indicated a notable correlation among refined grains, yield stress, and fracture topography within the studied materials [4].

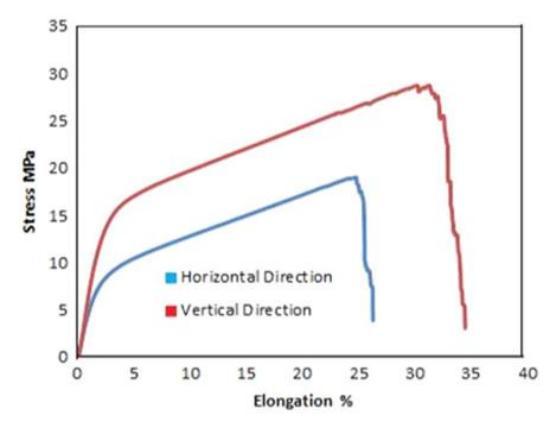
**Figure 2.** Tensile testing on cellular microstructure with 15% volume fraction and 3 mm unit cell size's stress-strain curves [10].

Another study [10], the tensile strength and fracture toughness of 316L stainless steel featuring a cellular microstructure produced via selective laser melting (SLM). This study investigated the impact of various microstructures on density, tensile strength, and fracture toughness related to the cellular formation. The findings are as follows: (1) The solid bases' relative density in both vertical and horizontal directions reached 96.25%, while the cellular microstructure density was recorded at 1.35 g/cm<sup>3</sup> for both orientations. (2) Vertically fabricated samples exhibited nearly 60% higher tensile and ultimate yield strengths compared to horizontally produce ones. In addition, vertical samples showcased approximately 40% higher elongation than their horizontal counterparts.

This difference could be attributed to the comparatively weaker nature of horizontally manufactured unit cells. (3) Tensile specimens within the cellular microstructure cracked near the end solid plane. This occurrence stemmed from a sudden density shift, causing a change in toughness and consequent stress concentration at the interface, resulting in fracture. (1) The fracture toughness of 316L stainless steel's cellular microstructure was measured at 3.3 MPa· $\sqrt{m}$  for horizontally generated samples and 4.3 MPa· $\sqrt{m}$  for vertically produced ones. While factors such as base metal density and loading rate may influence fracture toughness, the microstructure's orientation significantly impacts (2)The Gibson-Ashby it. micromechanical model proves beneficial in determining fracture toughness for materials with a cellular microstructure. The findings from the single edge notch bend (SENB) and the micromechanical model exhibit no discernible difference, ranging between 0.2 to 0.5 MPa· $\sqrt{m}$ [10].

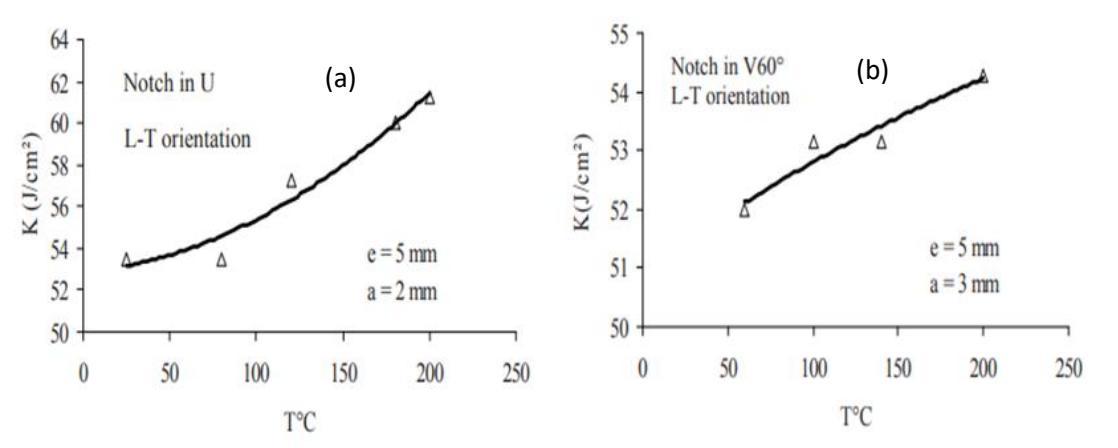
Figure 3. Impact resistance versus temperature: (a) V-shaped groove with an angle of 60 degrees and (b) U-shaped groove [11].

In a research study on 316L stainless steel, impact testing was utilized to examine its behavior under varying temperatures. Multiple impact tests were conducted at different the influence temperatures, revealing of temperature changes on both impact resistance and fracture energy. The Charpy test specimen was used to assess the impact of groove depth and angle, elucidating the material's formability behavior affected by temperature within the of 20-300 °C. Furthermore, range the investigation highlighted the significant impact of various geometrical features, such as the shape of the slit (U or V) and angle. Specifically, the sample with a U-shaped gap exhibited greater resistance compared to the sample with a Vshaped gap, maintaining consistency in temperature and thickness. Furthermore, within the V-shaped gap sample, an increase in the angle resulted in enhanced toughness [11].

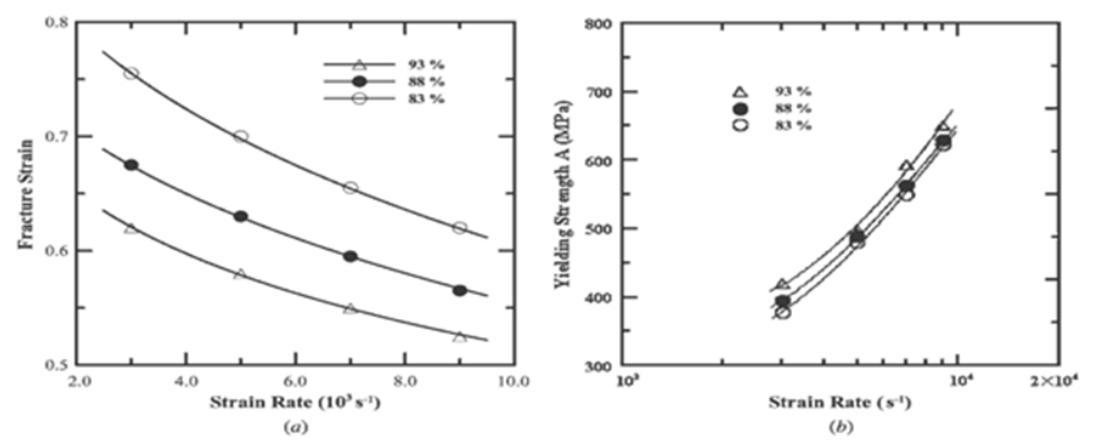
**Figure 4.** (a) Failure strain and strain rate relationships for various relative porosity densities and (b) Yield strength variation with strain rate for various relative porosity densities [12].

A study looked at how sintered 316L stainless steel deformed and fractured under varied strain rates and relative porosity density circumstances [12]. The study involved fabricating samples of 316L stainless steel with varying relative sintered densities (83%, 88%, and 93%) and subjecting them to dynamic impact testing and low strain pressure tests with strain rates ranging from  $3x10^3$  to  $9x10^3$  (S<sup>-1</sup>) and  $10^{-3}$  to  $10^{-1}$ (S<sup>-1</sup>). The results revealed that both the relative density of porosity and the strain rate significantly influenced the mechanical behavior of the steel, particularly showing distinctions between low and high strain rates.

Increasing the strain rate and relative porosity density was found to enhance fracture stress while reducing the failure strain. Interestingly, the variation in strain rate had a more pronounced effect on stress and strain compared to changes in relative porosity. High strain rates caused samples to exhibit greater sensitivity to strain rate compared to those subjected to lower strain rates of 10<sup>-3</sup> to 10<sup>-1</sup> (S<sup>-1</sup>). Moreover, it was observed that elevating the strain rate while maintaining a constant relative density, or increasing the relative porosity density while keeping a consistent strain rate, amplified the sensitivity to strain rate. These findings also highlighted different mechanisms governing deformation at low and high strain rates.

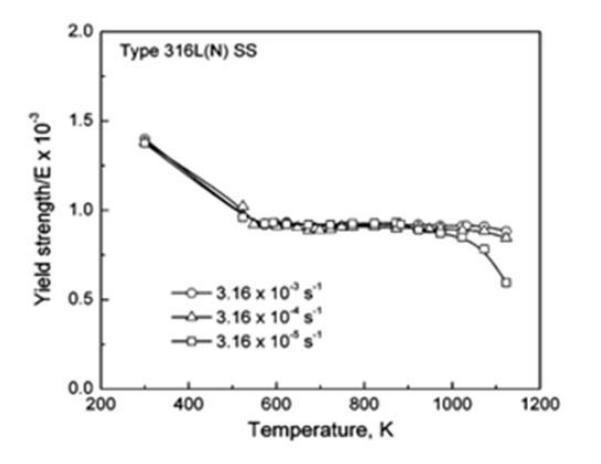
**Figure 5.** Yield strength variations with temperature and various strain rate [13].

In this investigation, the impact of temperature and strain rate on the tensile deformation and fracture behavior of 316L (N) austenitic stainless steel was explored. Various parameters like stress changes, tensile strength, and ductility values were measured using metrics such as uniform elongation, elongation to break, and decrease in cross-sectional area across different temperature ranges. Distinctive behavior was observed in three separate temperature ranges. When the temperature was varied from 300 K (27 °C) to 523 K (250 °C), it resulted in marked alterations in stress and strength data. Higher temperatures led to a rapid decline in strength while exhibiting a substantial increase in tensile ductility after reaching its minimum at room temperature. At moderate temperatures, the steel exhibited microstructures distinct from those observed at lower and higher temperatures. The research highlighted the significant impact of negative strain rate sensitivity on values such as stress-strength, average work-hardening rate, and minimum ductility at an average temperature. Across all test conditions, the steel consistently displayed an intergranular fracture pattern.

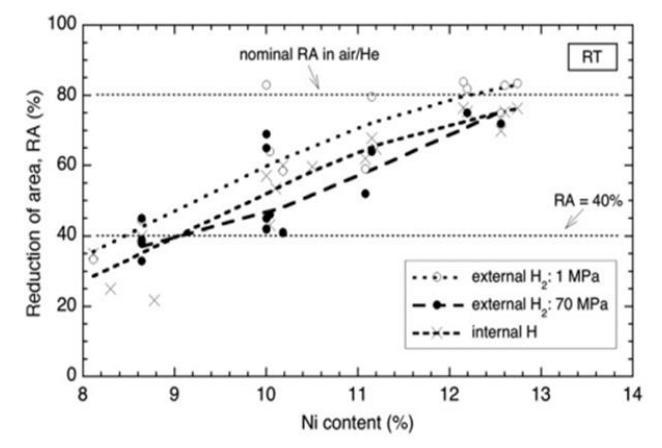
**Figure 6.** Reduction in cross-sectional area for the tensile test at room temperature as a function of nickel concentration. The measurement was performed using hydrogen gas at a pressure of 70 MPa [14].

The physical differences between the tensile tests of austenitic stainless steels 304 and 316 conducted in the presence of internal and external hydrogen were assessed by a research [14]. Hydrogen-induced stress concentration and its role in aiding crack propagation significantly influence hydrogen-induced fracture in various settings. The presence of hydrogen often triggers a localized fracture process, leading to the expansion of stress-sensitive material fissures that compromise the tensile strength of the material. Alloys with lower nickel content and exposure to lower temperatures tend to be more vulnerable to hydrogen-induced fracture propagation.

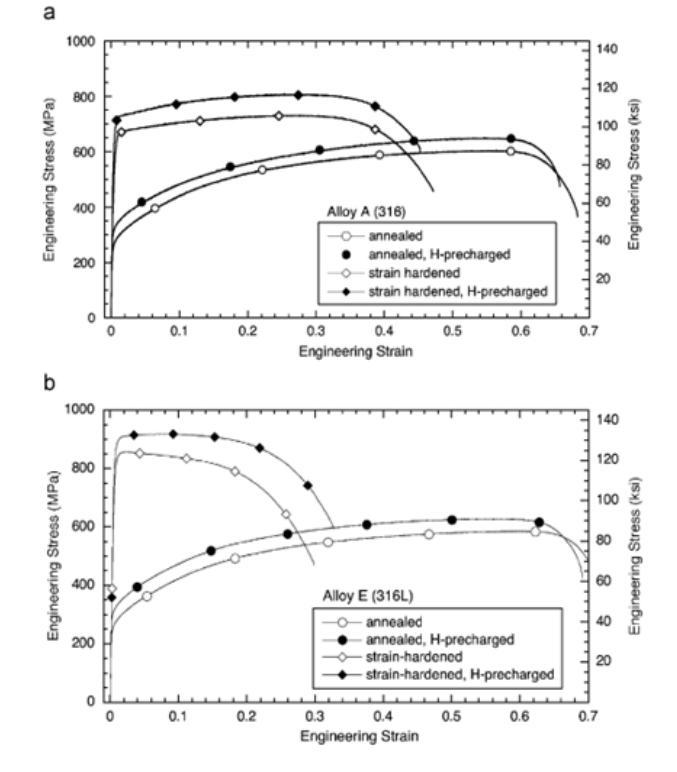
**Figure 7.** Tensile curves in annealed conditions and strain hardened in conditions without hydrogen and precharged hydrogen [15].

as observed within the parameters of this study. The observed variation in tensile ductility can be attributed to hydrogen-assisted fracture growth. Materials inherently susceptible to hydrogen develop exposure may internal cracks. contributing to potential material failure. Tensile strength serves as an indicator to assess the extent of these processes. The study revealed that hydrogen-induced fracture in austenitic stainless steels, during tensile testing, involves a competition between stress concentration and hydrogen-induced crack propagation. Tensile strength diminishes when hydrogen-induced fracture propagation takes precedence. However, in hydrogen-rich environments where failure is primarily due to stress concentration, tensile strength does not decrease [7]. Another study examined the effects of alloy composition and strain hardening on tensile fracture in precharged 316 stainless steels [8]. The research identified that a 136 vppm internal hydrogen concentration, generated through thermal precharging of hydrogen gas, led to reduced tensile ductility in 316 stainless steel. However, both annealed samples and strain-hardened microstructures showed minimal loss in ductility despite this hydrogen concentration. The relatively high ductility observed in both hydrogen-pre-charged and non-hydrogencharged samples suggests the involvement of plasticity processes in the types of tensile failure observed. The presence of internal hydrogen was found to either reduce nucleation sites or promote localized slips, strengthening interparticle bonds. Nickel's significance in deformation processes appeared crucial, as higher nickel content in 316 stainless steels seemed to offer increased resistance to hydrogen-induced fracture. Furtehrmore, while carbon was anticipated to contribute to the stability of 316 stainless steel due to straininduced martensite formation, it was observed to have no discernible impact on hydrogen-induced fracture [15].

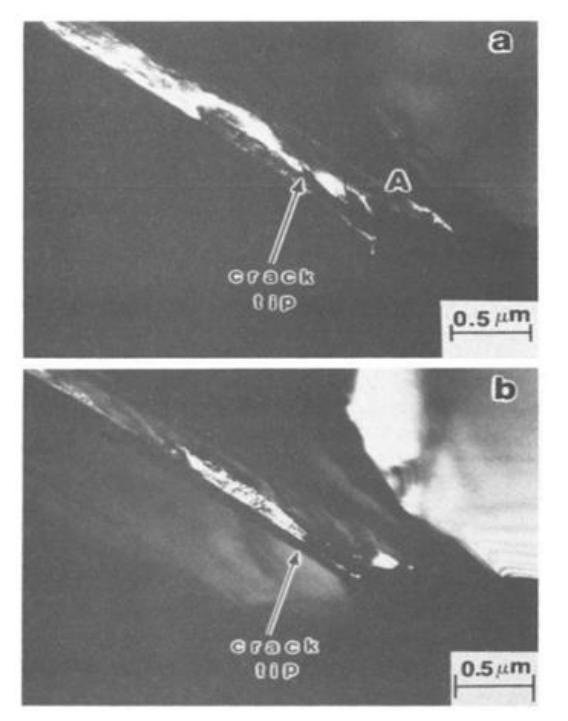
**Figure 8.** Strained in a vacuum, the sensitized steel exhibits martensitic phases in an intergranular fracture. The dark field images are related to (a) diffraction spots of martensite  $\varepsilon$  and (b) martensite  $\alpha'$  [16].

3. Along the fracture surfaces and in front of the crack tip, martensite phases with  $\varepsilon$  and  $\alpha'$  structures were found to occur, according to the research. It was discovered that cracks spread along the active slip planes and into the  $\varepsilon$  martensite phase. On the other hand, the  $\alpha'$  phase was consistently seen in high-stress areas [16].

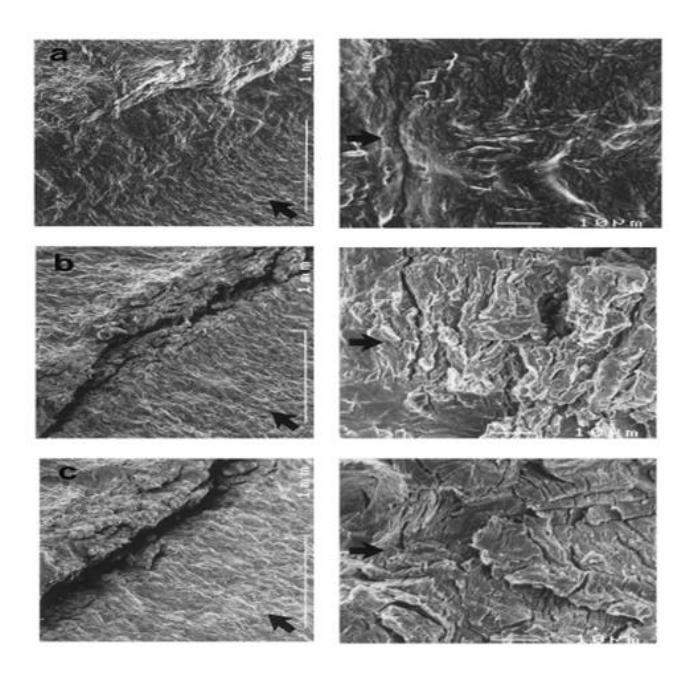
**Figure 9.** Fracture tip as shown in SEM photos just before maximum loading: (a) hydrogen-free and (b,c) under hydrogen charging at 10 and 1 mm/min, respectively [17].

Another study investigated hydrogen-induced fracture in 316L stainless steel samples with primary cracks [17]. Tensile testing conducted on 316L austenitic stainless steel specimens, both with and without concurrent cathodic polarization, revealed that hydrogen-induced damage did not significantly alter the macroscopic failure mechanism of the specimens when subjected to slow loading. Under these test conditions, hydrogen damage manifested as cracking phenomena restricted to the fracture accelerating rupture by root. generating additional branches from the original break.

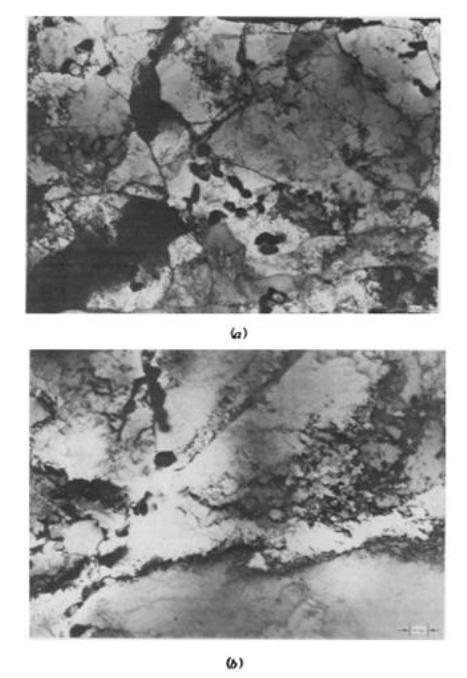
**Figure 10.** SEM images of samples heat treated at 700 °C. (a) Base sample, rupture life = 1075 h, elongation = 44% and (b) Helium fraction =  $4 \times 10^{-5}$  atom, rupture life = 316 h, and elongation = 13% [18].

Investigations were also done on how helium affected the stress fracture behavior of 316 stainless steel [18]. These are the findings of this research study: 1. The presence of helium in 316 stainless steel leads to a reduction in both the elongation rate and the material's rupture life.

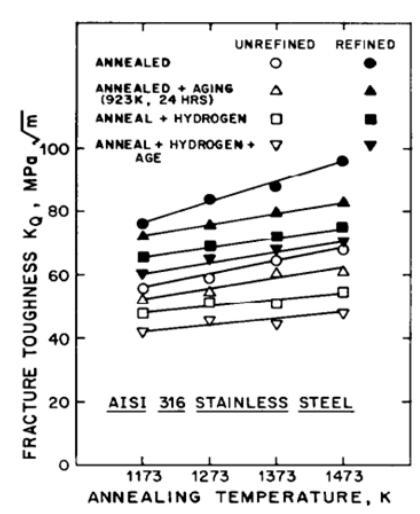
**Figure 11.** Fracture toughness diagram according to annealing temperature [19].

results were obtained. 1. Unmodified steel generally exhibits lower toughness properties compared to modified steel. This disparity often arises from the larger grain size present in unmodified steel in contrast to the smaller grains found in modified steel. 2. Hydrogen embrittlement tends to be more pronounced in

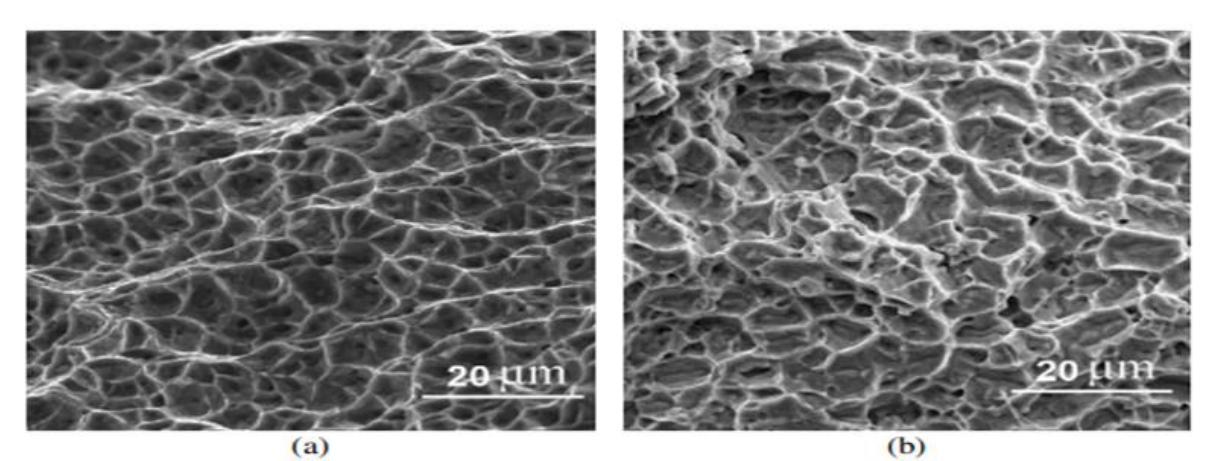
**Figure 12.** Dimples on the weld metal fracture surface as seen in SEM photos (a) without aging and (b) aged with shear fracture mode [20].

Another study [20] looked at how 316L stainless steel weld metal's fracture and roomand high-temperature tensile characteristics were affected by aging. The following are the findings of this research:

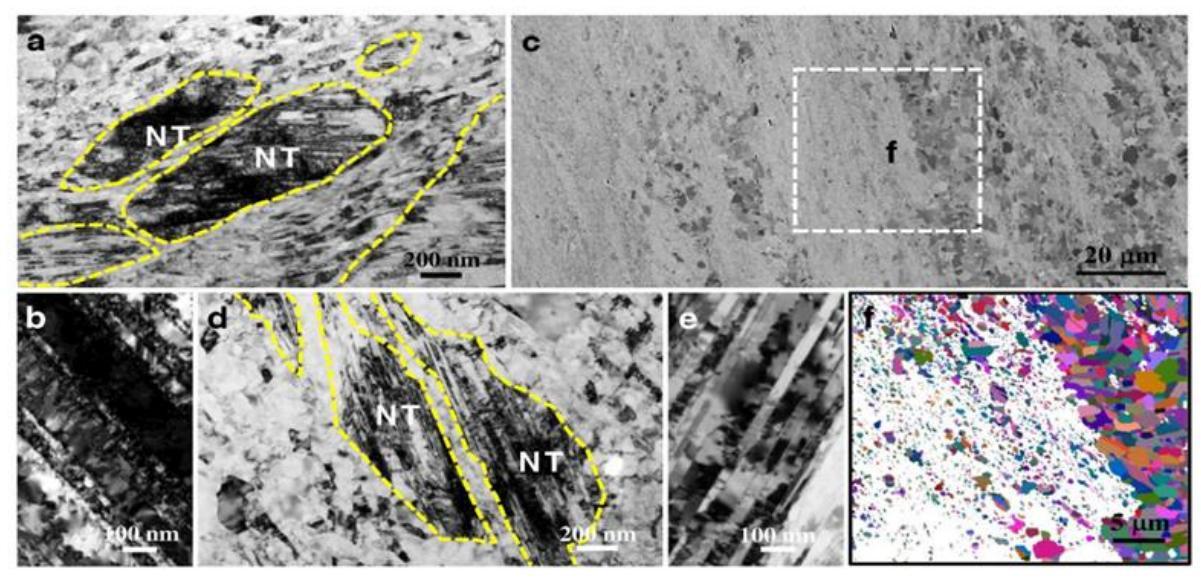
Figure 13. (a) A nanograin structure with nanotwin (NT) bands is seen in the cross-section microstructure of 316L steel, (b) a TEM picture of twins under strain that has a lot of accumulated dislocations, (c) a cross-section SEM picture of the sample's microstructure after it was annealed at 720 °C reveals some grains that have recrystallized, (d) a closer TEM study of the undissolved portions in (c) reveals nanotwin bands encircled by coaxial grains that are less than one micron in size, (e) TEM picture of nanotwins that have been annealed and have a low dislocation density, and (f) an EBSD map of the area in (c) that was chosen, showing the presence of high-angle grain boundaries and grains that have recrystallized with annealing twins [1].

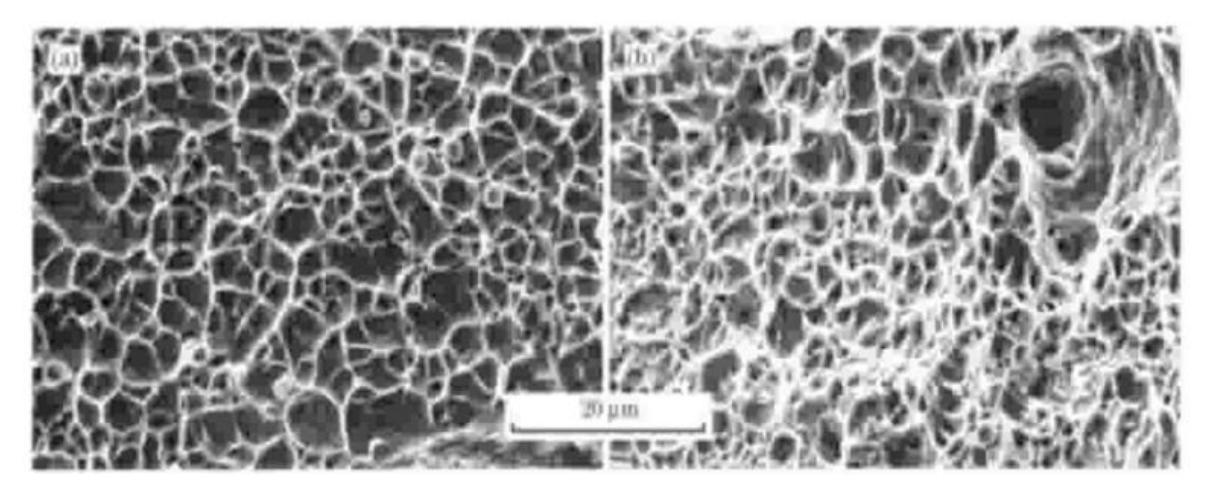
Figure 14. SEM images of fracture morphology: (a) heated rolled sample and (b) dissolved annealed sample [21].

1. The strength and elongation of the solutionannealed sample were found to be better than those of the hot-rolled sample. The higher density and depth of the dimples observed in the annealed sample can explain its better elongation. Furthermore, the amount of ferrite decreased from 10% to 6% after the dissolution treatment, which contributed to improved corrosion properties.

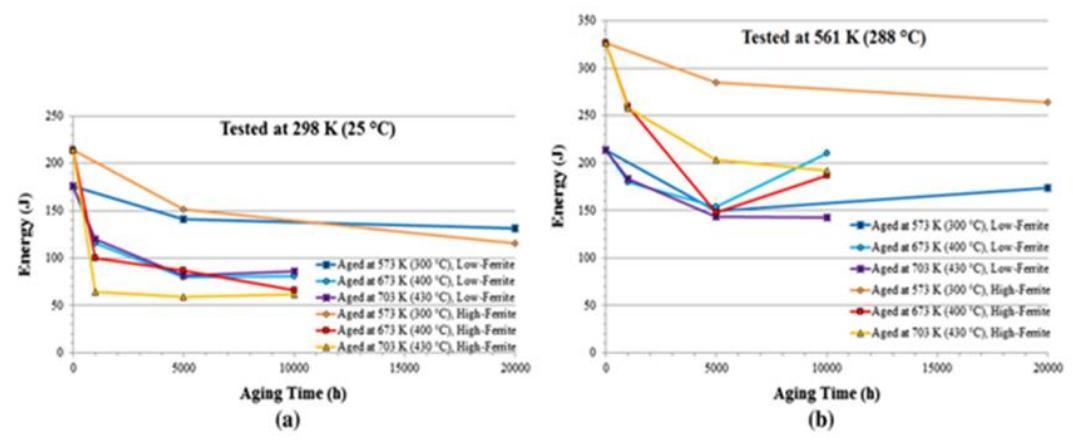
**Figure 15.** Results of the Charpy V-notch impact toughness test are provided for materials with low and high delta ferrite values (a) at 298 K (25 °C) and (b) at 561 K (288 °C) [22].

3. As aging time and temperature rise, the impact energy shown in the Charpy V-notch test falls until it approaches saturation. The delta ferrite phase experiences brittle failure after saturation. The quantity of ferrite phase present, the test temperature, and the aging temperature are some examples of variables that affect the saturation of impact toughness.

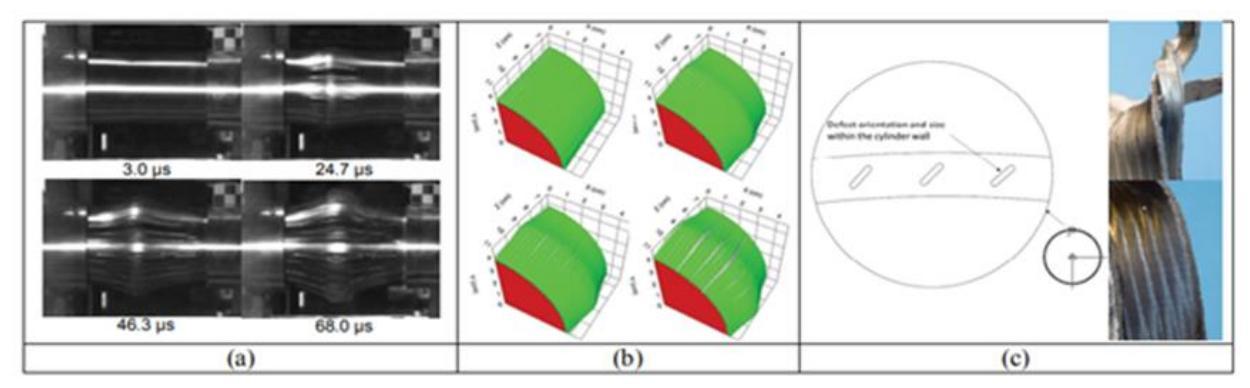
**Figure 16.** (a) Images captured by the Phantom V1610 camera show the expansion and failure of an AM stainless steel cylinder that contained defects created during the manufacturing process. The times given are according to the impact time. The projectile hits the middle point from the left side. The cutting area can be seen as strips along the length of the cylinder, (b) 3D simulations completed in CTH, and (c) images of the recovered parts show the strain's location along the defect plane [23].

Investigations have been done into the fracture properties of 316L stainless steel manufactured with additives or cylinders of the same steel made from wrought iron rods and put under stress [23]. The gas gun approach for expanding cylinder testing makes it possible to evaluate the ductility of metals as well as the processes of corrosion and fracture that take place during the high-speed tensile test. Through these tests, the strain rate may change from 10<sup>-2</sup> to 10<sup>-4</sup> (S<sup>-1</sup>). The findings showed that, in the examined strain rate range, an additively manufactured cylinder failed at a greater strain than cylinders produced of forged rods.

Furthermore, the effect of macroscopic holes put at a 45 degree angle to the cylinder radius was examined. Results from simulations and experiments (using the Eulerian hydrocode CTH) were contrasted as well. Four 316L stainless steel cylinders were tested to failure, and the strain-to-failure values (a measure of ductility) showed that the AM cylinder (manufactured by additive material technique) was more ductile than its conventional counterpart. It is suggested that this change in ductility was due to the preferential orientation of the grains formed during the AM fabrication process. The orientation control of the defect site or locations was

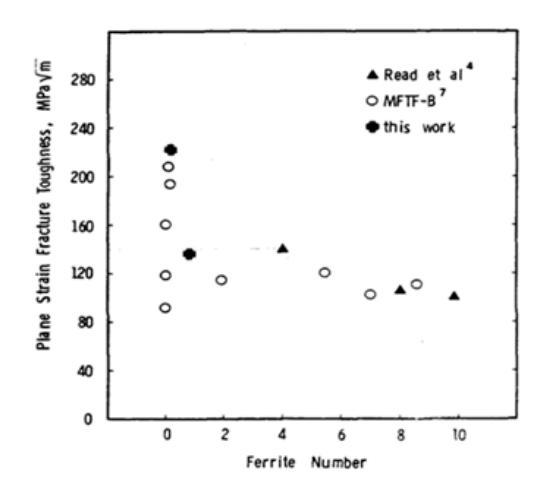
**Figure 17.** The influence of the amount of ferrite phase in weld on the fracture toughness of 316L weld [24].

Another study looked at the connection between the 316L stainless steels totally austenitic microstructure and fracture behavior in welded joints [24]. In comparison to standard 316L filler material, the fracture toughness of multi-pass weld deposits made using Mnmodified 316L filler material (4-5 wt%) was found to be less than 100 (MPa. $\sqrt{m}$ ). Although gentle rupture causes failure in both materials, the fracture route varies. The results display the "cordurov" morphological fracture surface. Surfaces in samples under strain and compression had corresponding cracks that revealed a sparse amount of typical 316L weld The fracture deposits. morphology and toughness of welded joints may be connected to the microstructural stability of austenite during testing, according to a suggested model. Manganese and molybdenum that precipitate at cell dendritic borders during weld solidification have a tendency to stabilize the austenite and stop martensite from forming there. Therefore, in Mn-modified weld deposits, fracture preferentially occurs at these boundaries, leading in a "corduroy" fracture morphology and poorer fracture resistance than in weld deposits where martensite formation is more homogenous [24].

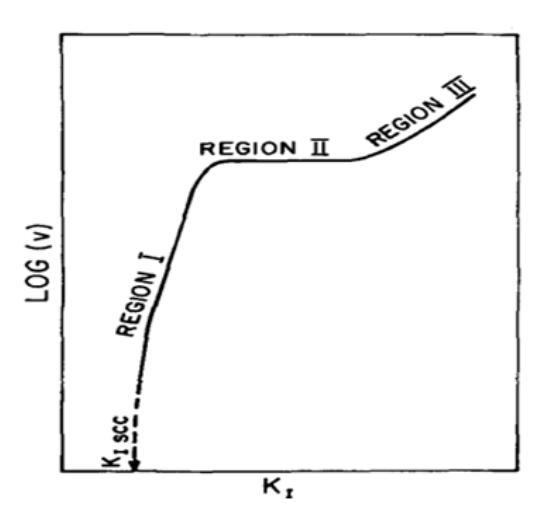
Figure 18. Schematic behavior (KI-logv) for SCC [18].

2. When the value of  $K_I$  was increased, three consecutive regions of  $K_{1-\nu}$  behavior were observed. In region I, the  $K_I$  behavior was dependent on the rate. In region II, its rate remained constant and was independent of the  $K_I$ value. This was followed by region III, where the value of  $\nu$  was again observed to be dependent on  $K_I$ .

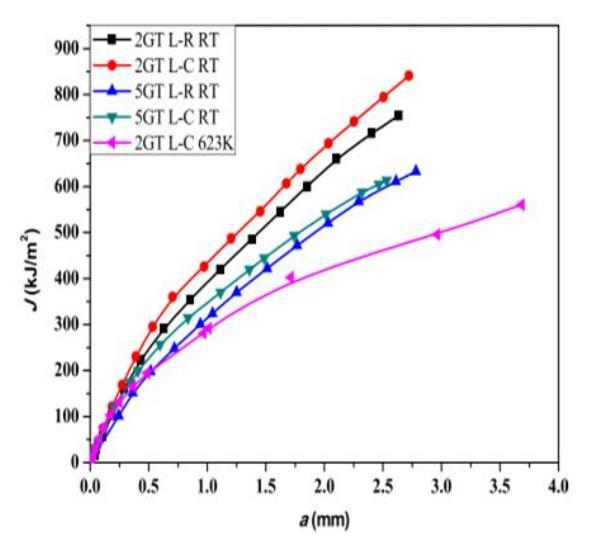
**Figure 19.** J-R diagrams for 2GT and 5GT connections [26].

In another investigation [26], the fracture toughness of two kinds of 316LN steel welded joints was assessed at 300 and 623 K in air in various directions. The tests were carried out using the single sample approach, where fracture toughness values (J0.2) and J-R curves are computed. Before and after the test, the samples' microstructure was assessed. According to the findings, the 2GT welded joint, which has minimal bearing on fracture toughness. In addition, when temperature rises, fracture toughness falls significantly. The findings of this study are outlined as follows:

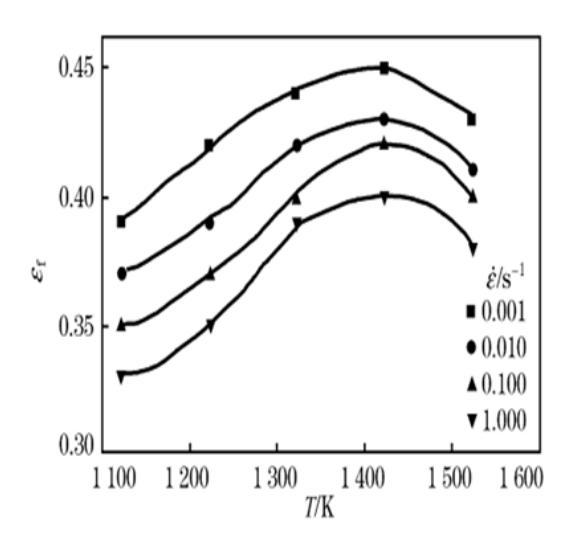
Figure 20. Values of the critical strain of failure ( $\epsilon_f$ ) at different strain rates and temperatures [27].

1. Based on the findings of the tensile tests, a model was created to estimate the material's critical failure strain as a function of temperature and strain rate.
